Manhole Inspection Summary

Manhole # S43II_056MH

Insp Date: **4/25/08 9:43 AM**

Location Address: **Regester St**

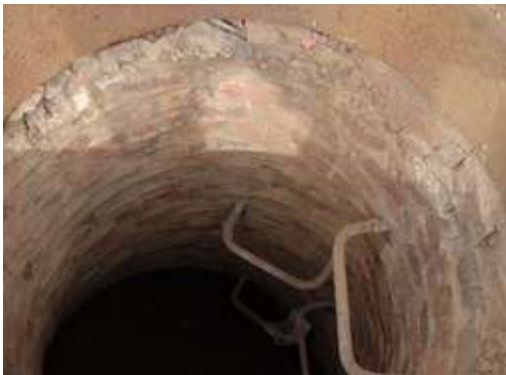
Defect 2

Infiltration: ☐ None ☒ **Joint** ☐ Cracks ☒ **Mortar** ☐ Roots ☐ Wall

Infiltration: ☐ None ☐ Joint ☐ Cracks ☐ Mortar ☐ Roots ☒ **Wall**

Infiltration

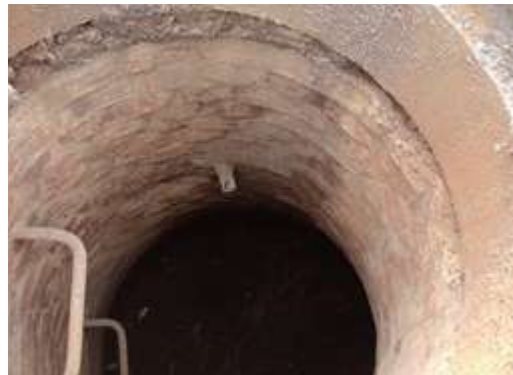
Defect 1

Condition: ☐ Sound ☐ Cracked ☐ Root Intrusion ☒ **Loose Brick** ☒ **Deteriorated**

Deterioration

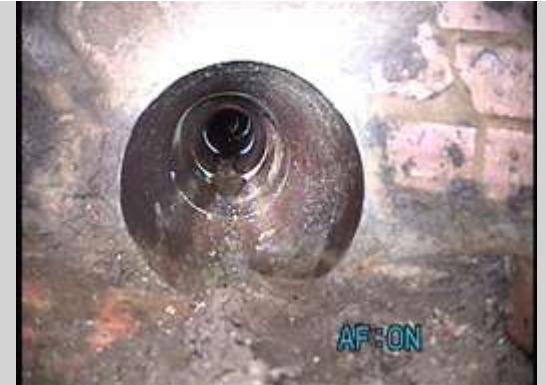
12 O'Clock Outflow

8 in. Circular Gravity Sewer
Pipe Out @ 12 O'Clock

Infiltration: **None** Pipe Seal Cond: **Sound**
